Facility: BP Cherry Point Refinery
Location: Blaine, Washington

EPA ID No.: 1000 0004 8307

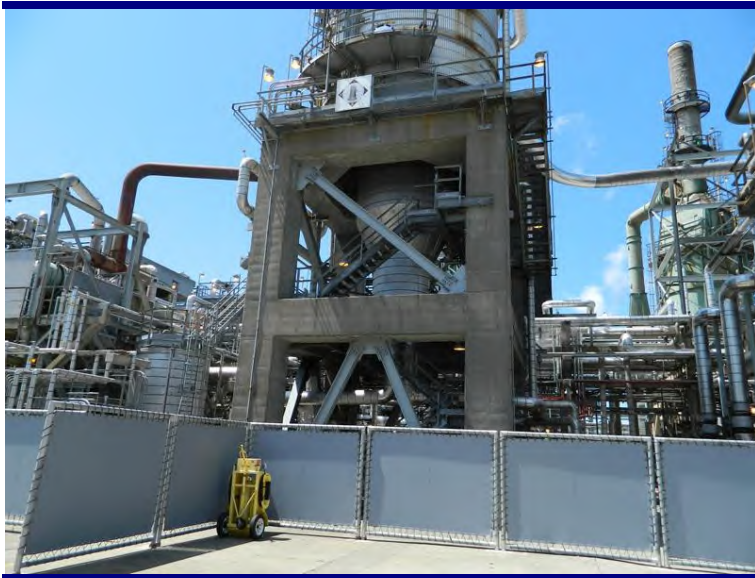
DSCN0184.jpg Date: 6/10/13 Time: 12:55 Direction: West
Vacuum Tower in Crude Unit (fire occurred in this area).

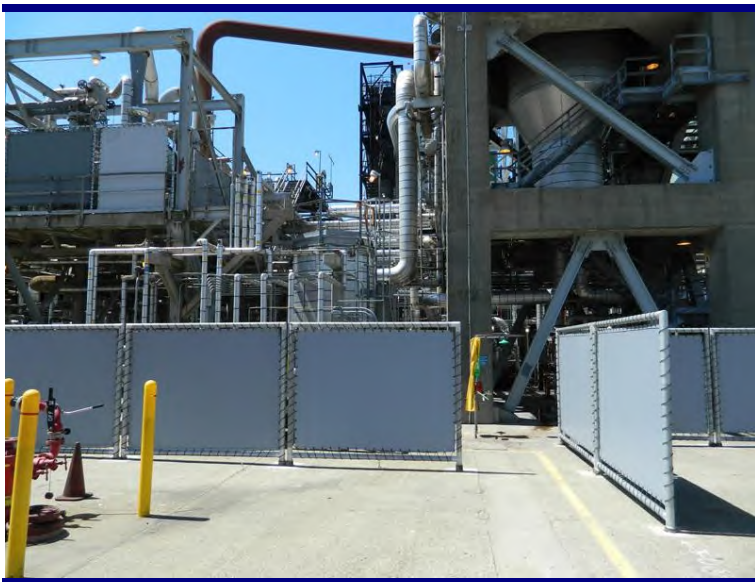
DSCN0194.jpg Date: 6/10/13 Time: 13:19 Direction: West
Horizontal pipes in Crude Unit where fire occurred.

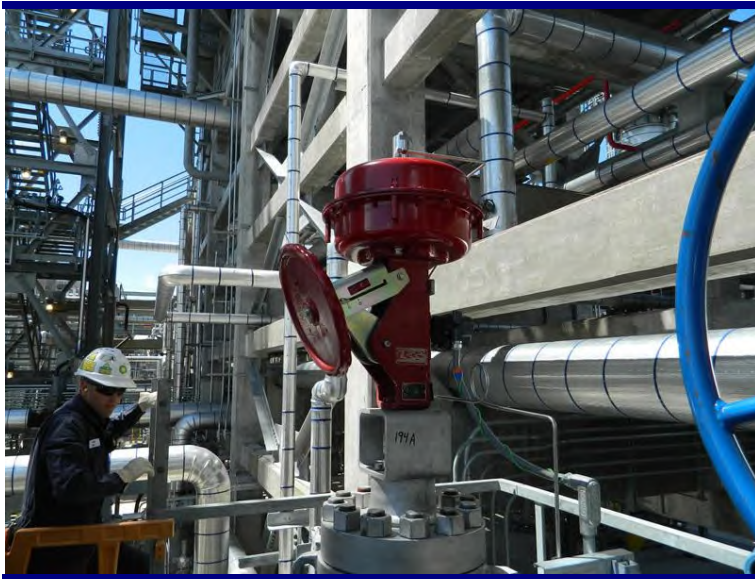
DSCN0212.jpg Date: 6/11/13 Time: 14:14 Direction: West
#3 Diesel HPS level control valve 194A.

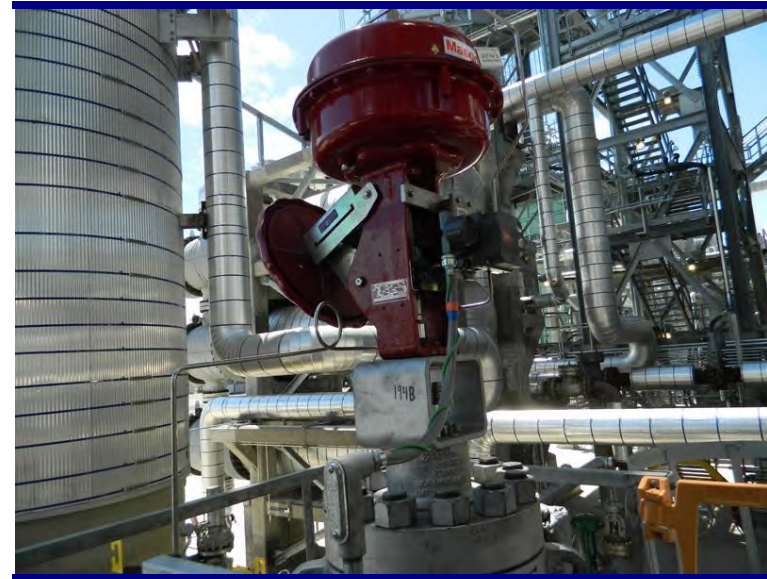
DSCN0213.jpg Date: 6/11/13 Time: 14:15 Direction: Southwest
#3 Diesel HPS level control valve 194B.

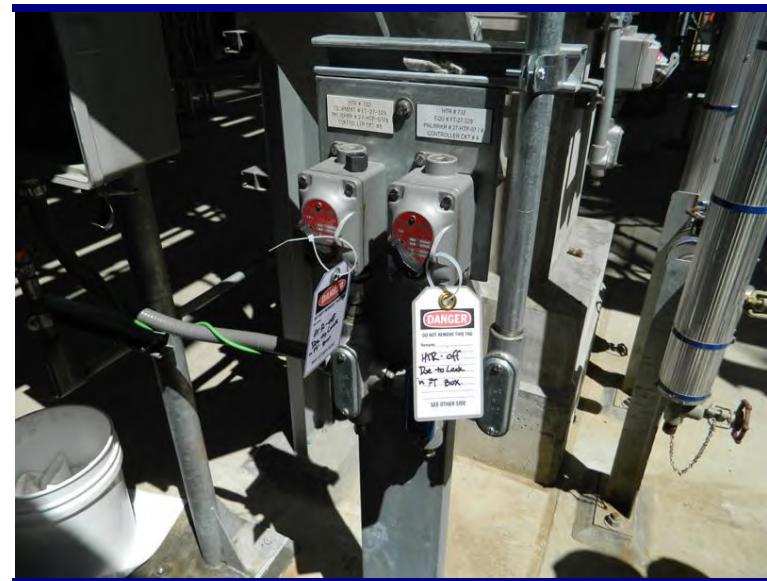
DSCN0215.jpg Date: 6/11/13 Time: 14:20 Direction: East
Locked-out heat trace switch in #3 Diesel.

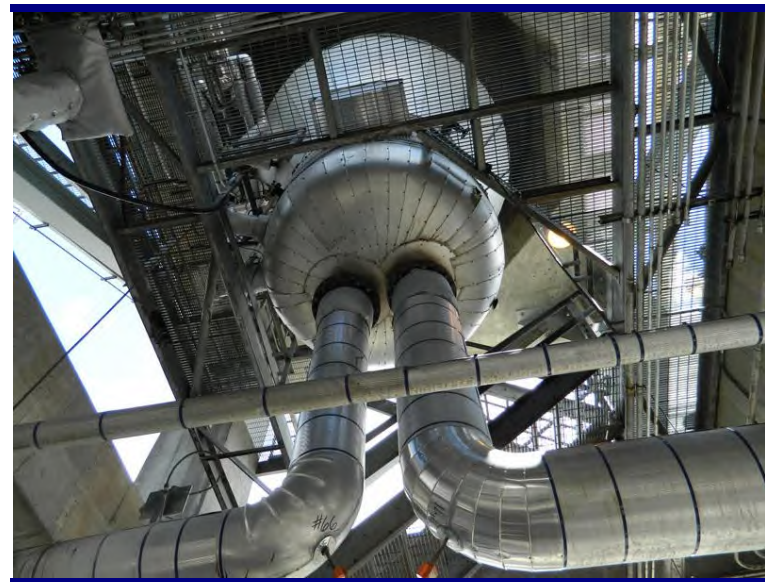
DSCN0239.jpg Date: 6/13/13 Time: 13:20 Direction: Up
Vacuum tower bottoms outlet piping.

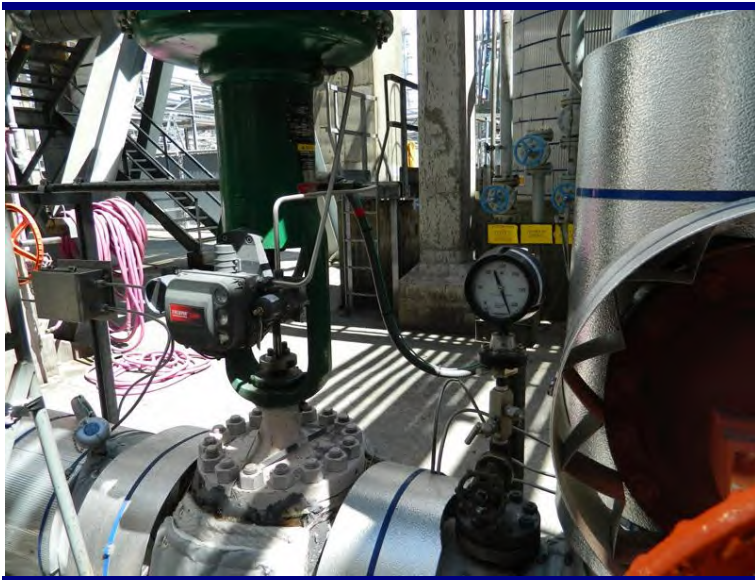
DSCN0242.jpg Date: 6/13/13 Time: 13:26 Direction: East
Valve and gauge (beyond maximum gauge range) LV-10-100.

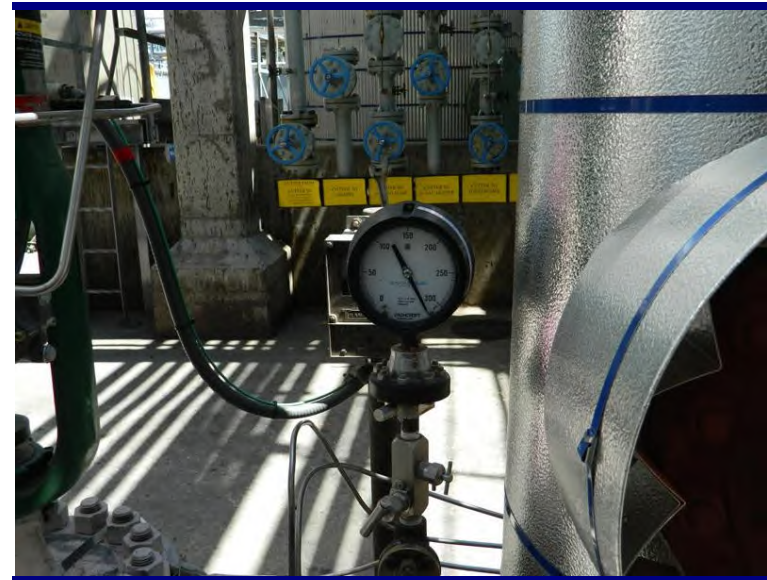
DSCN0243.jpg Date: 6/13/13 Time: 13:29 Direction: East
Valve and gauge (beyond maximum gauge range) LV-10-100.

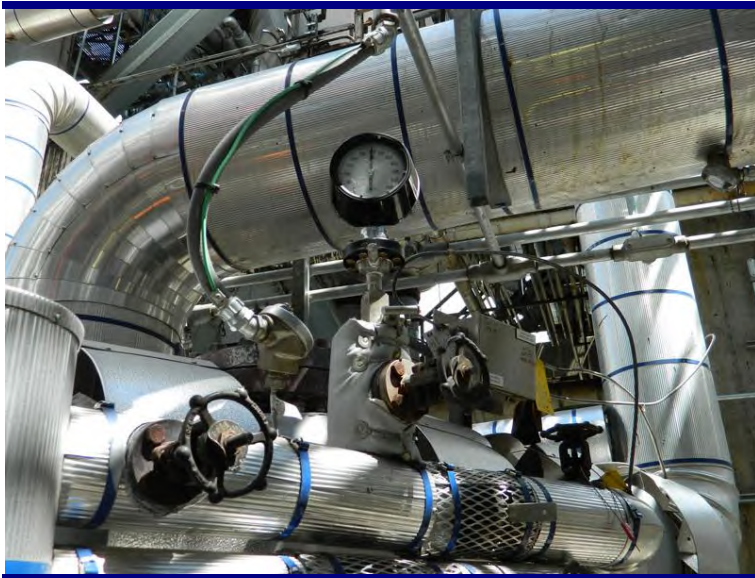
DSCN0244.jpg Date: 6/13/13 Time: 13:31 Direction: East/Up
Gauge on vacuum bottoms piping.

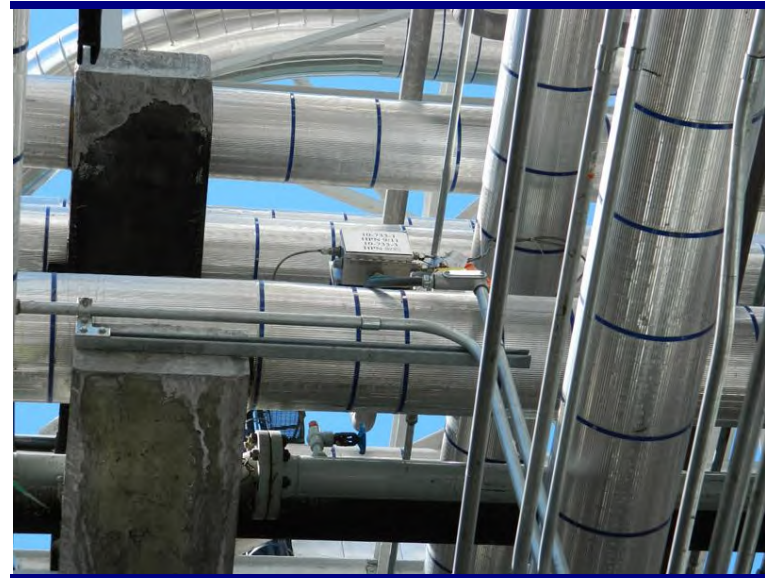
DSCN0245.jpg Date: 6/13/13 Time: 13:35 Direction: West/Up
Vacuum start-up line.

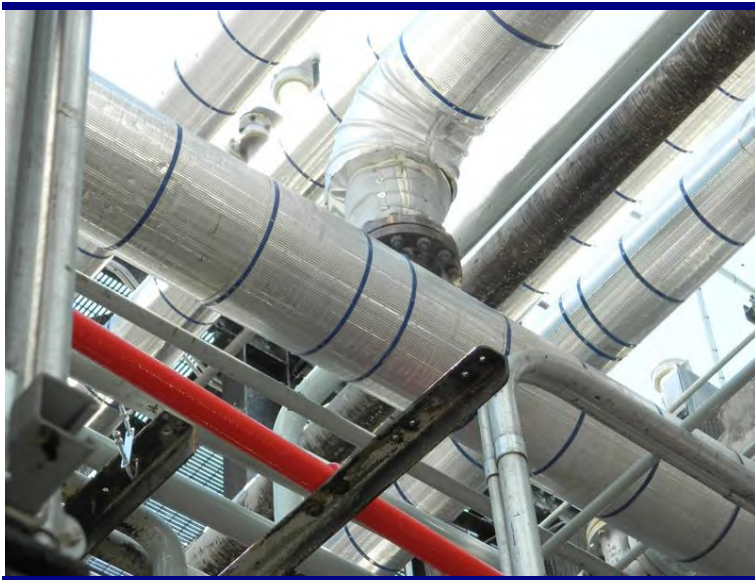
DSCN0246.jpg Date: 6/13/13 Time: 13:36 Direction: South/Up
Vacuum start-up line/stagnant line where thermal syphon and fire occurred.
